# Unique Resolute Ball™ Design Provides Reliable Service in Pulp & Paper Application

## APPLICATION DETAILS

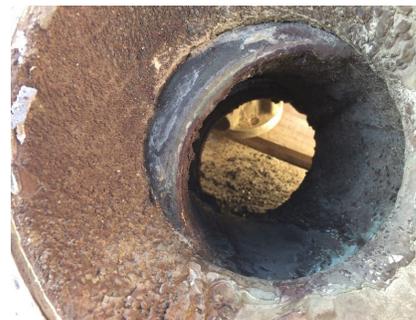
*After 2 months in service, a competitor's valve showed signs of upstream severe media buildup — causing frequent leaks and lockups.*

In this application for green and white liquor isolation, competitor ball valves were experiencing frequent failures caused by calcified media buildup. Upstream media buildup was leading to scoring of the seat and ball during operation, causing the valves to leak prematurely. In addition, severe buildup was causing higher valve torques — resulting in failure to operate. With failures occurring after only 2 months in service, the shutdowns and repairs were becoming very costly to operations.

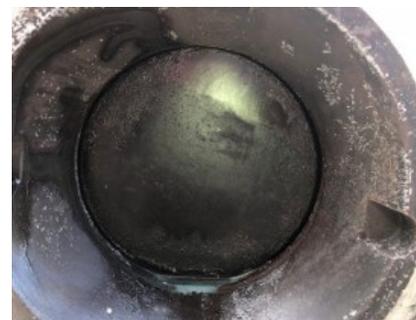
*After 18 months in service with no issues, the valve showed no signs of wear or upstream media buildup.*

After installing the 4 valves, they continued in service for 18 months, until they were removed for evaluation during a scheduled plant maintenance shutdown. The valves had no leaks and showed no signs of wear, so they were reinstalled. The customer was so impressed with the results that they ordered 18 more valves for isolation service, ranging in size from NPS 4 to 10 (DN 100 to 250). The 22 valves are stroked monthly to flush the media, and have continued in service for more than 4 years with no issues.
