# M1 Severe Service Ball Valve Extends Service Life 4 Years in HPAL Autoclave Isolation

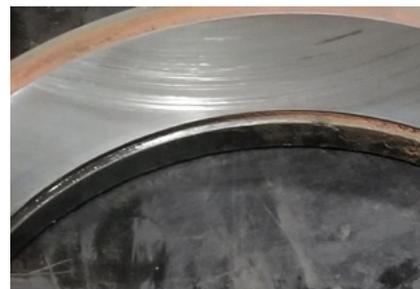
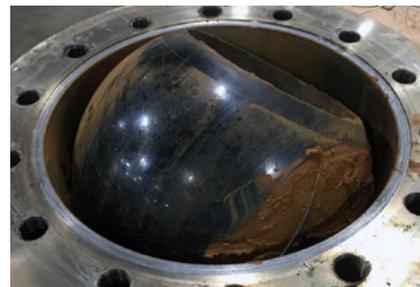
Five years after the initial installation, Bray recommended removing the valve during the next scheduled shutdown, for a preventative refurbishment — even though it was not leaking beyond the customer’s acceptable parameters. Upon receipt at the Bray facility, the M1 inspection found minimal wear to the sealing components — and only minor material displacement at the stem-to-ball interface, caused by trapped line debris and high-volume cycling. The stem was replaced, and all other components were refurbished. The valve was reassembled, tested, and returned to the customer’s site for reinstallation.

**After 5 years of service, the ball and seats showed only minor scratches, and were refurbished for continued service.**
