Unique Resolute Ball™ Design Provides Reliable Service in Pulp & Paper Application

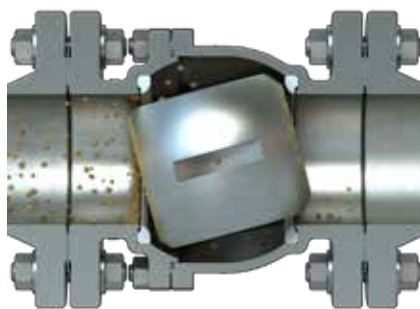
UNIQUE RESOLUTE BALL™

Modified ball design minimizes effects of media buildup on ball sealing surface and allows particles to flow through ball cavity.

Seat life is extended by eliminating contact between ball and seat after 10° of rotation.

Reduced valve torque is required to break minimal media buildup. Valve easily operates with standard actuation.

The Resolute Ball™ design was developed by working closely with the customer to understand and overcome the challenges of their application. The ball was designed as a direct replacement for standard balls within select Flow-Tek Valves. Media contact with the seat is minimized throughout the quarter-turn operation, while the modified ball geometry allows for media particles to be flushed past the ball and seats. This unique design provides improved operability, extended service life, reduced valve operating torque, increased reliability, and reduced total cost of ownership for the customer.

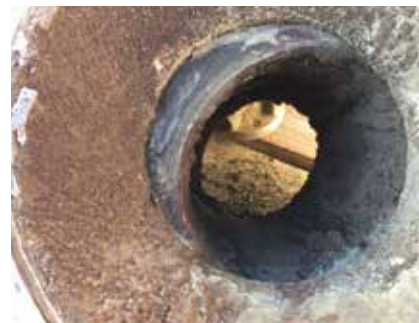
After 2 months in service, a competitor's valve showed signs of upstream severe media buildup — causing frequent leaks and lockups.

In this application for green and white liquor isolation, competitor ball valves were experiencing frequent failures caused by calcified media buildup. Upstream media buildup was leading to scoring of the seat and ball during operation, causing the valves to leak prematurely. In addition, severe buildup was causing higher valve torques — resulting in failure to operate. With failures occurring after only 2 months in service, the shutdowns and repairs were becoming very costly to operations.

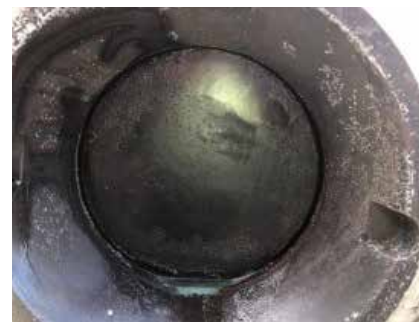
After 18 months in service with no issues, the valve showed no signs of wear or upstream media buildup.

After installing the 4 valves, they continued in service for 18 months, until they were removed for evaluation during a scheduled plant maintenance shutdown. The valves had no leaks and showed no signs of wear, so they were reinstalled. The customer was so impressed with the results that they ordered 18 more valves for isolation service, ranging in size from NPS 4 to 10 (DN 100 to 250). The 22 valves are stroked monthly to flush the media, and have continued in service for more than 4 years with no issues.
